# Preliminary Analyses of the Critical Discharge for Streambed Mobilization – Currys Fork Watershed

Prepared for Oldham Co. Fiscal Court  
By Sustainable Streams  
June 2020

The purpose of this memorandum is to document the methodology and results of the preliminary analyses of estimates of the critical discharge for streambed mobilization ( $Q_{critical}$ ). These preliminary estimates of the threshold discharge for streambed erosion can help to inform stormwater design targets for both new development and retrofits of existing stormwater control measures within the Currys Fork Watershed.

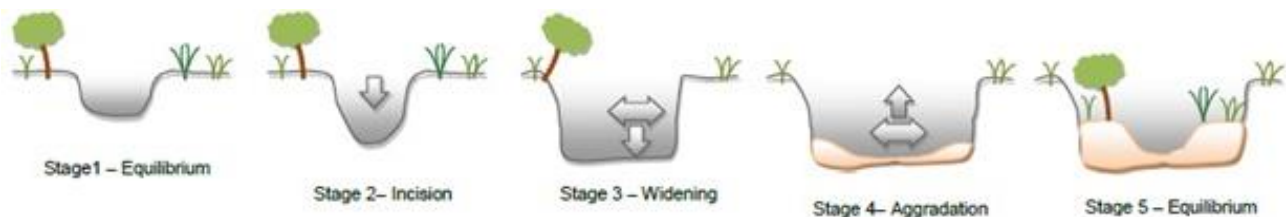
Figure 1: Channel evolution model (adapted from Schumm *et al.*, 1984)

The critical discharge for stream bed/bank erosion is known as  $Q_{critical}$ . Flows greater than this threshold will entrain bed particles, moving them downstream. While some bed disturbance is natural, developed watersheds tend to have flow regimes that cause more frequent disturbance to the bed, resulting in excess erosion in the stream system (Hawley and Vietz, 2016). To mitigate this excess erosion,  $Q_{critical}$  can be used as a target flow for stormwater management. With enough implemented stormwater management measures designed for channel stability, a transition from Stage 3 of the Channel Evolution Model (Figure 1) to Stages 4 and 5 could occur. In this transition, the toe of the bank is sequentially protected by bar development that is ultimately colonized by more permanently protective vegetation (i.e. similar to the pilot study conducted by Sustainable Streams, US EPA, and other partners, Hawley *et al.* (2017)).

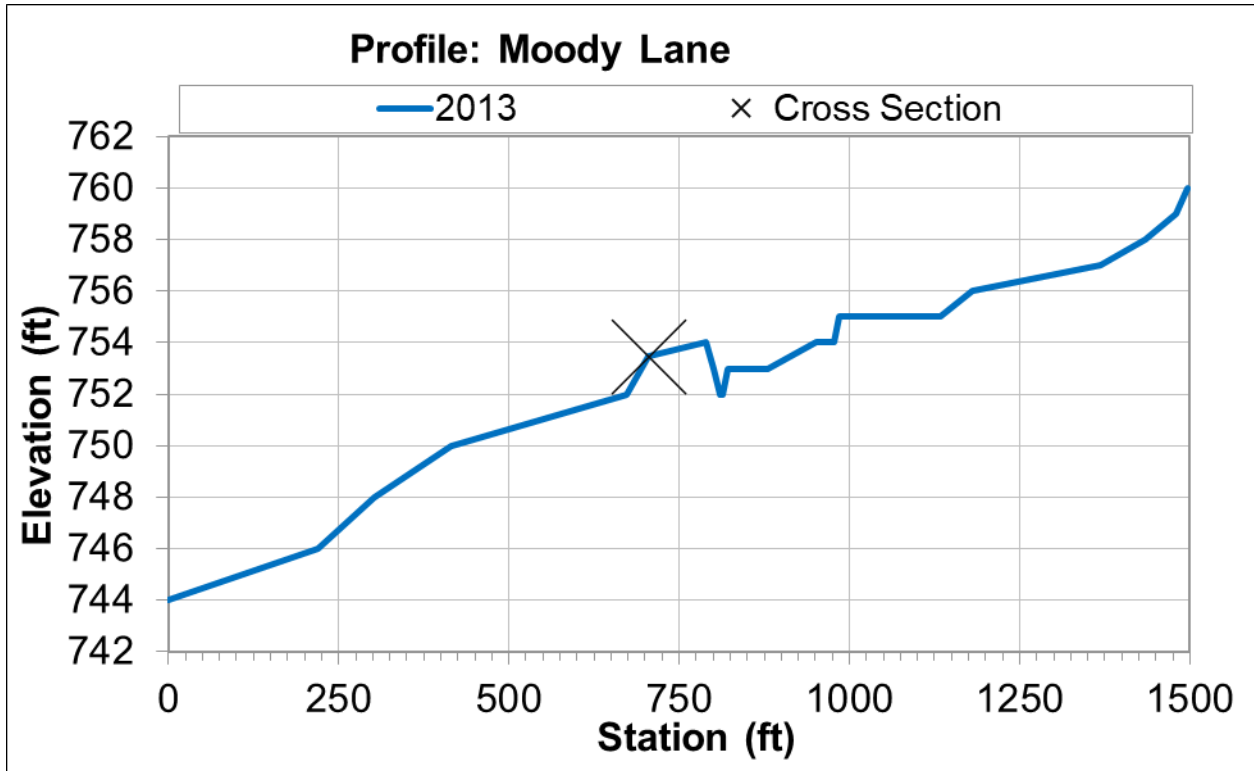
Figure B7: Profile at site

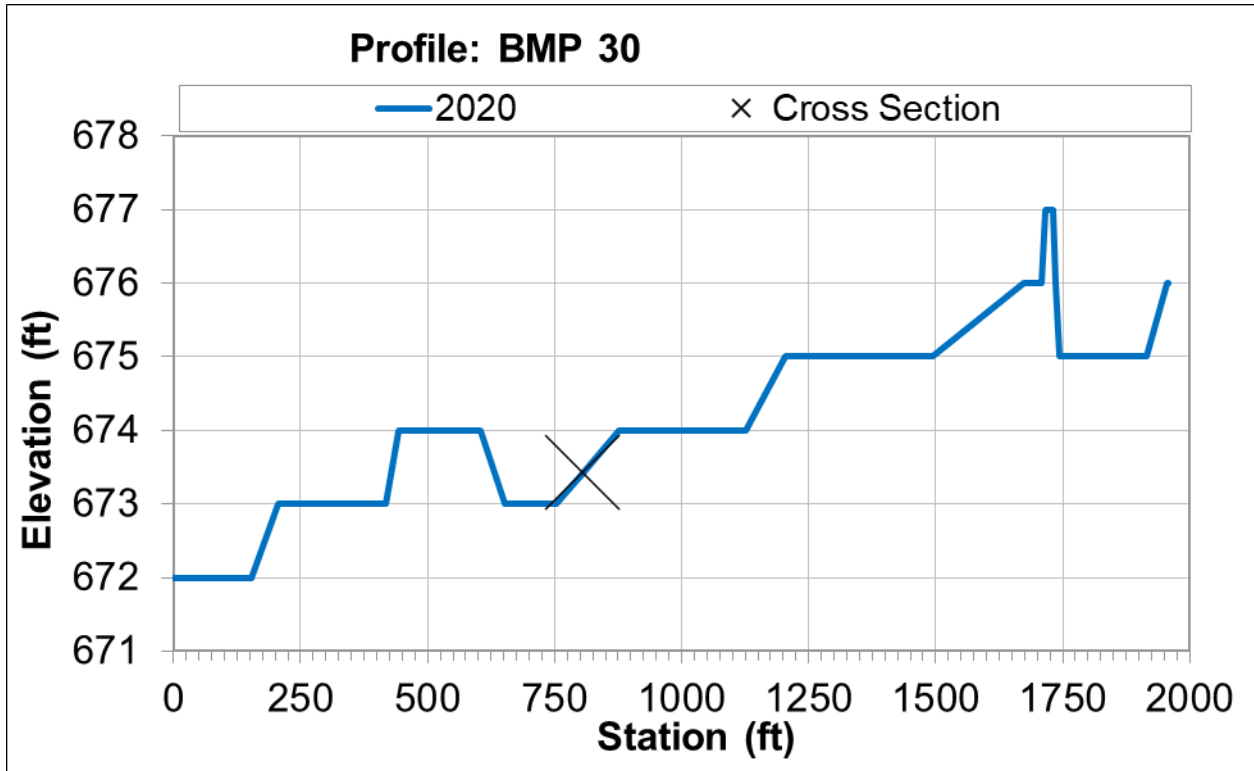
Figure B11: Profile at site

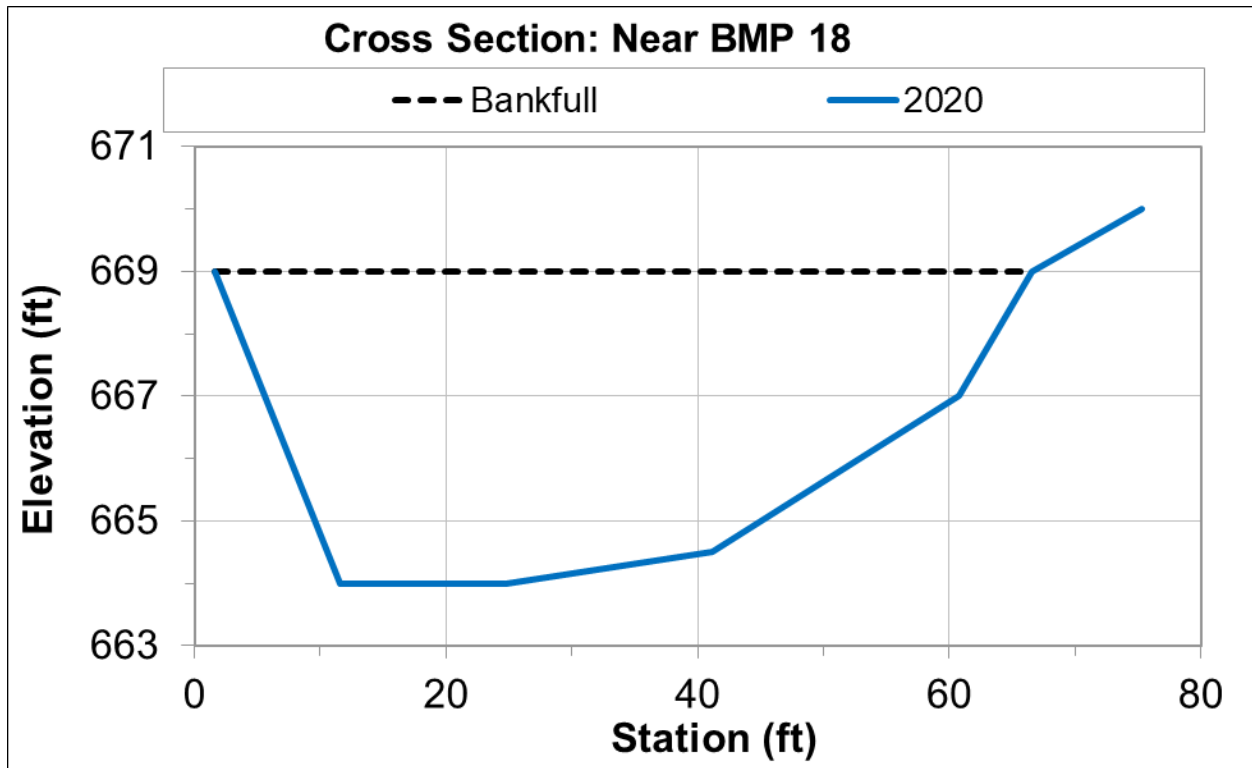
Figure B14: Cross section at site, looking downstream

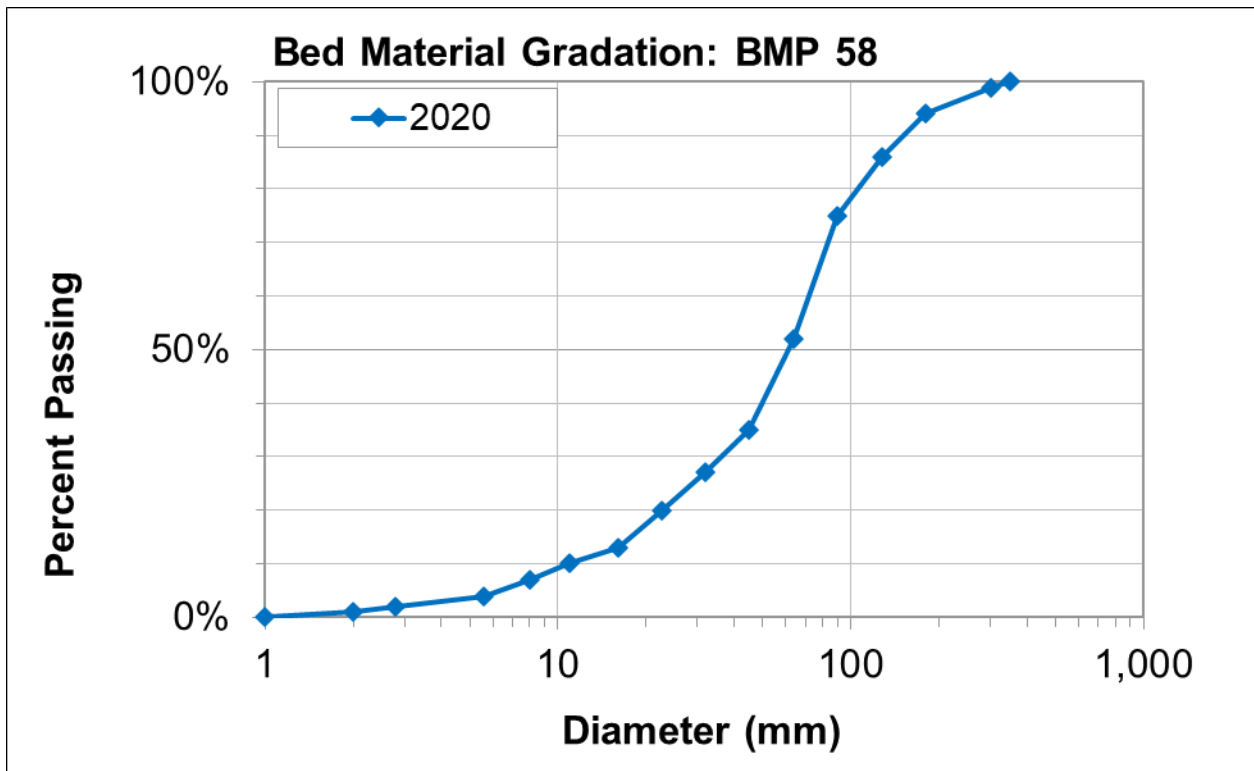
Figure B20: Bed material gradation at site
